Elevator Commissioning

A Near Miss Safety Incident Analysis

A case study of a near-miss electrical incident during elevator commissioning at a prestigious South Mumbai hotel, where a near miss accident was reported

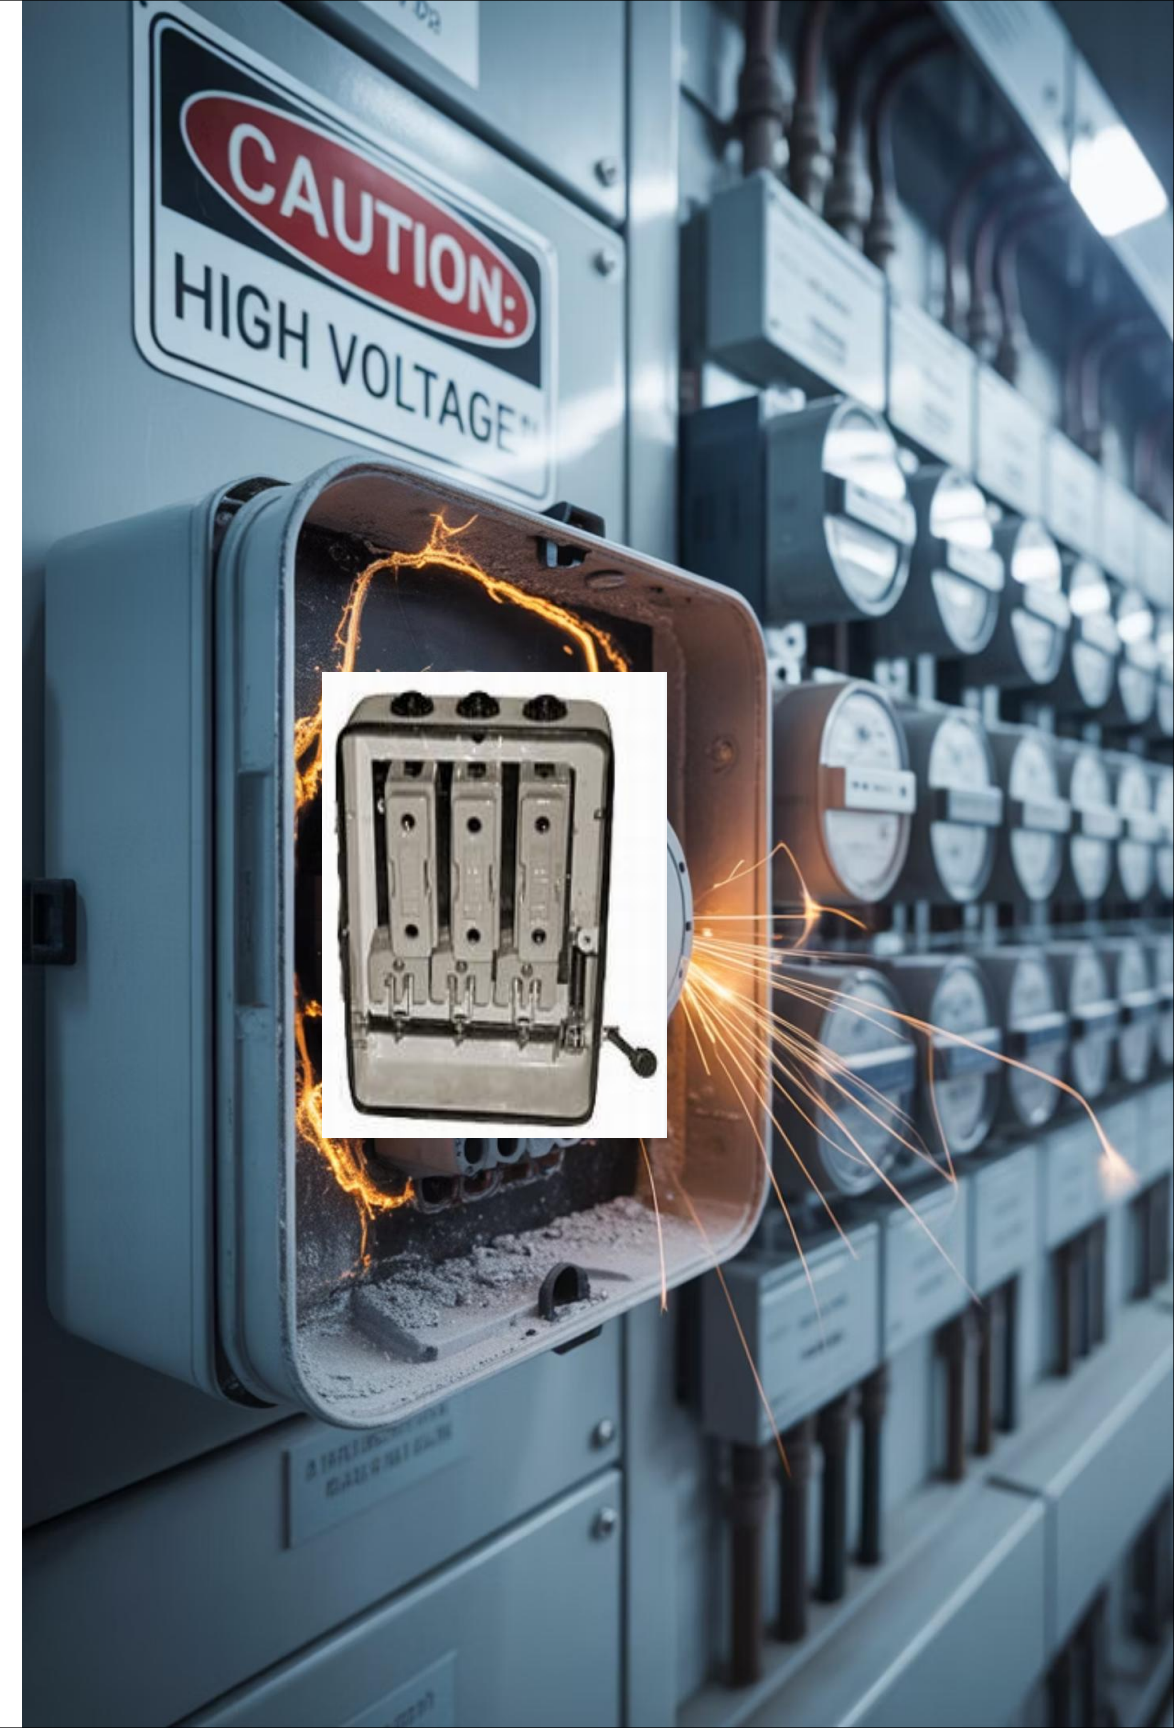
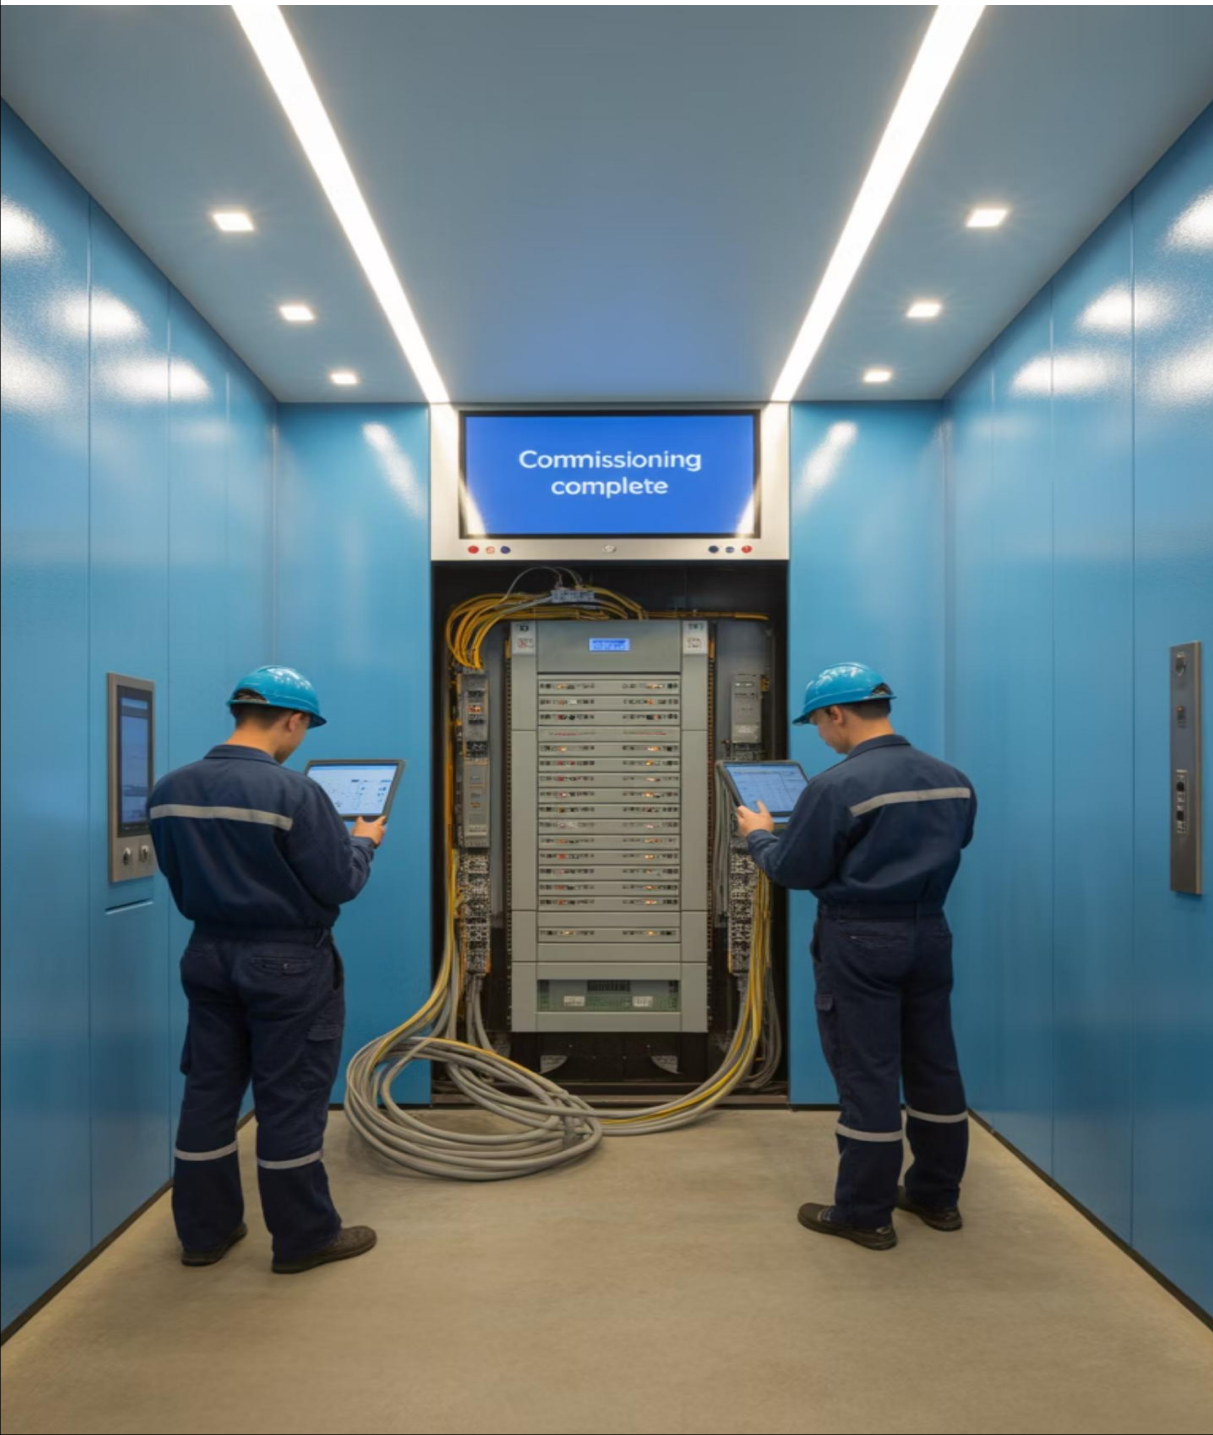
During elevator commissioning, a significant explosion occurred at the machine room main switch.

The explosion propelled the cover approximately ten feet from its original position

Fortunately, no personnel were in proximity to the main switch, preventing injuries.

The hotel maintenance team quickly replaced the main switch with a new one.

Power supply was successfully restored after the incident.

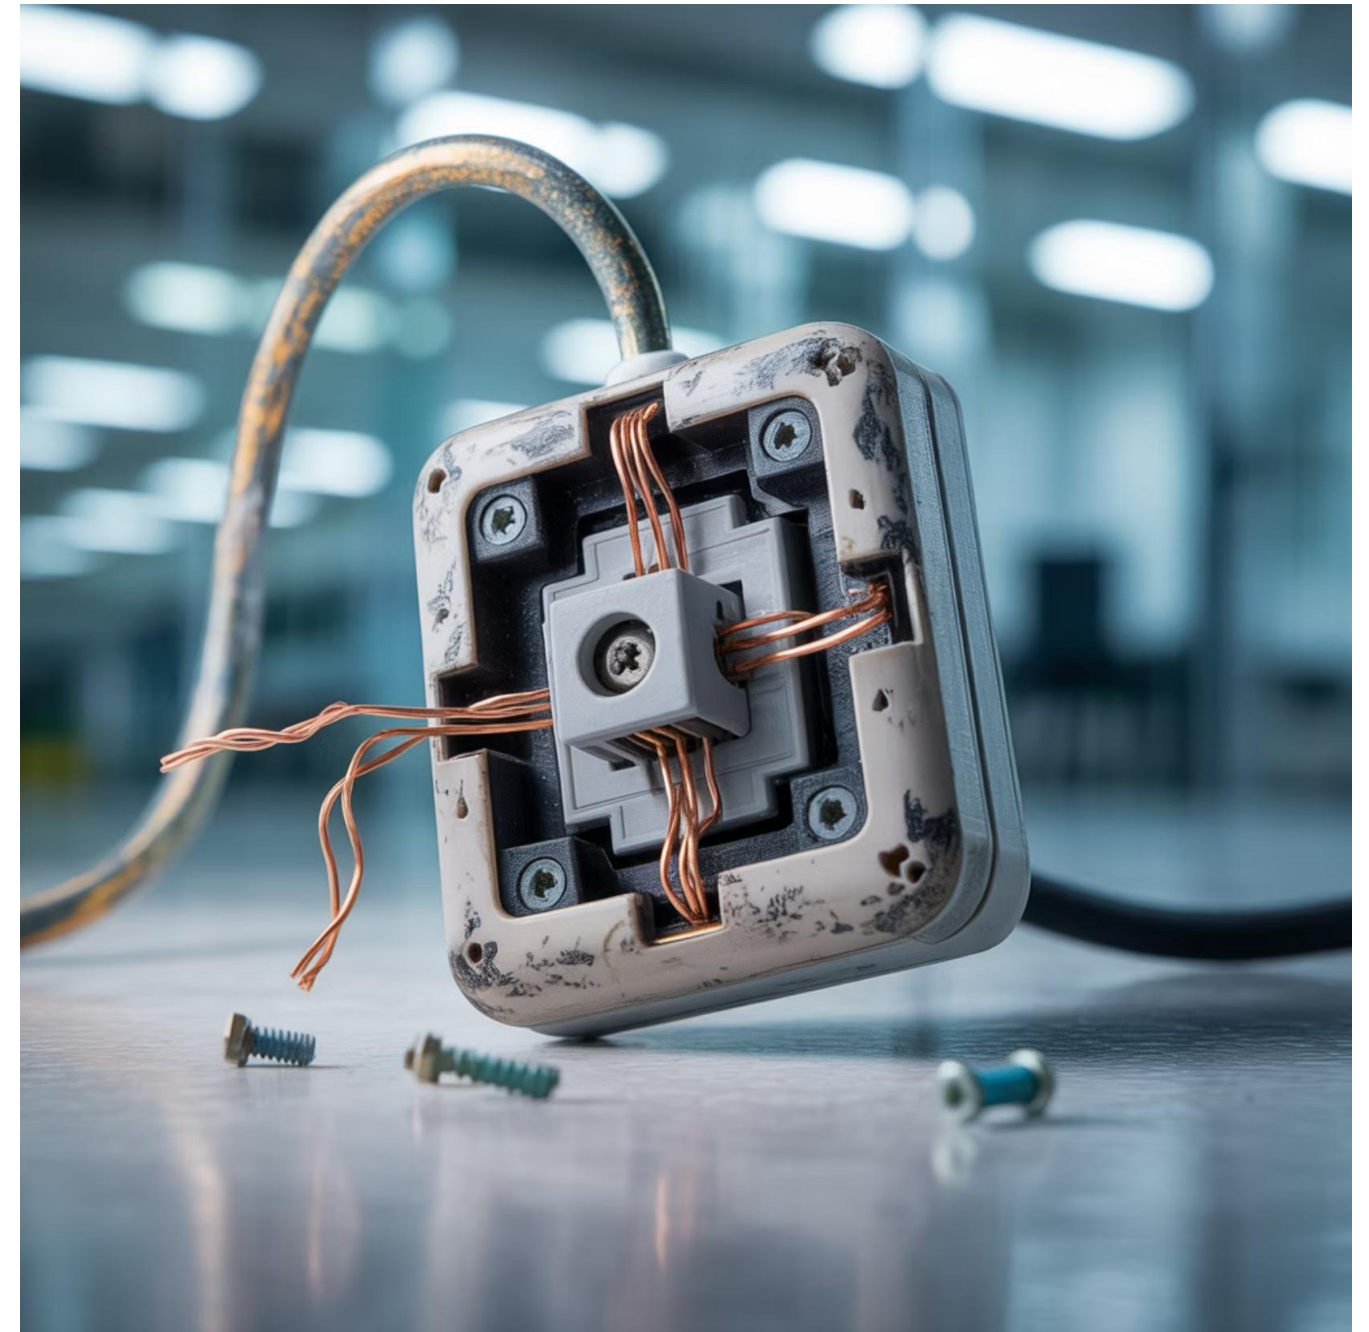
Temporary old iron clad power main switch was used by the project team.

Due to repeated use of the power handle, the phase wires got shorted inside the switch.

The screws fixing the cover were not properly secured - they were loose or missing.

The power main switches were thoroughly checked by the project team and restored to proper working order.

Emphasis on ensuring client-supplied main switches are in optimal condition with securely affixed covers. Recommend to use RCCB than Iron Clad main switches.
