Safety Tool Box Talk No 6

A comprehensive review of a serious elevator accident where a passenger fell into the shaft and was later got crushed by a descending elevator. This Safety TBT p examines the incident causes, investigation findings, and implemented safety measures to prevent similar occurrences.

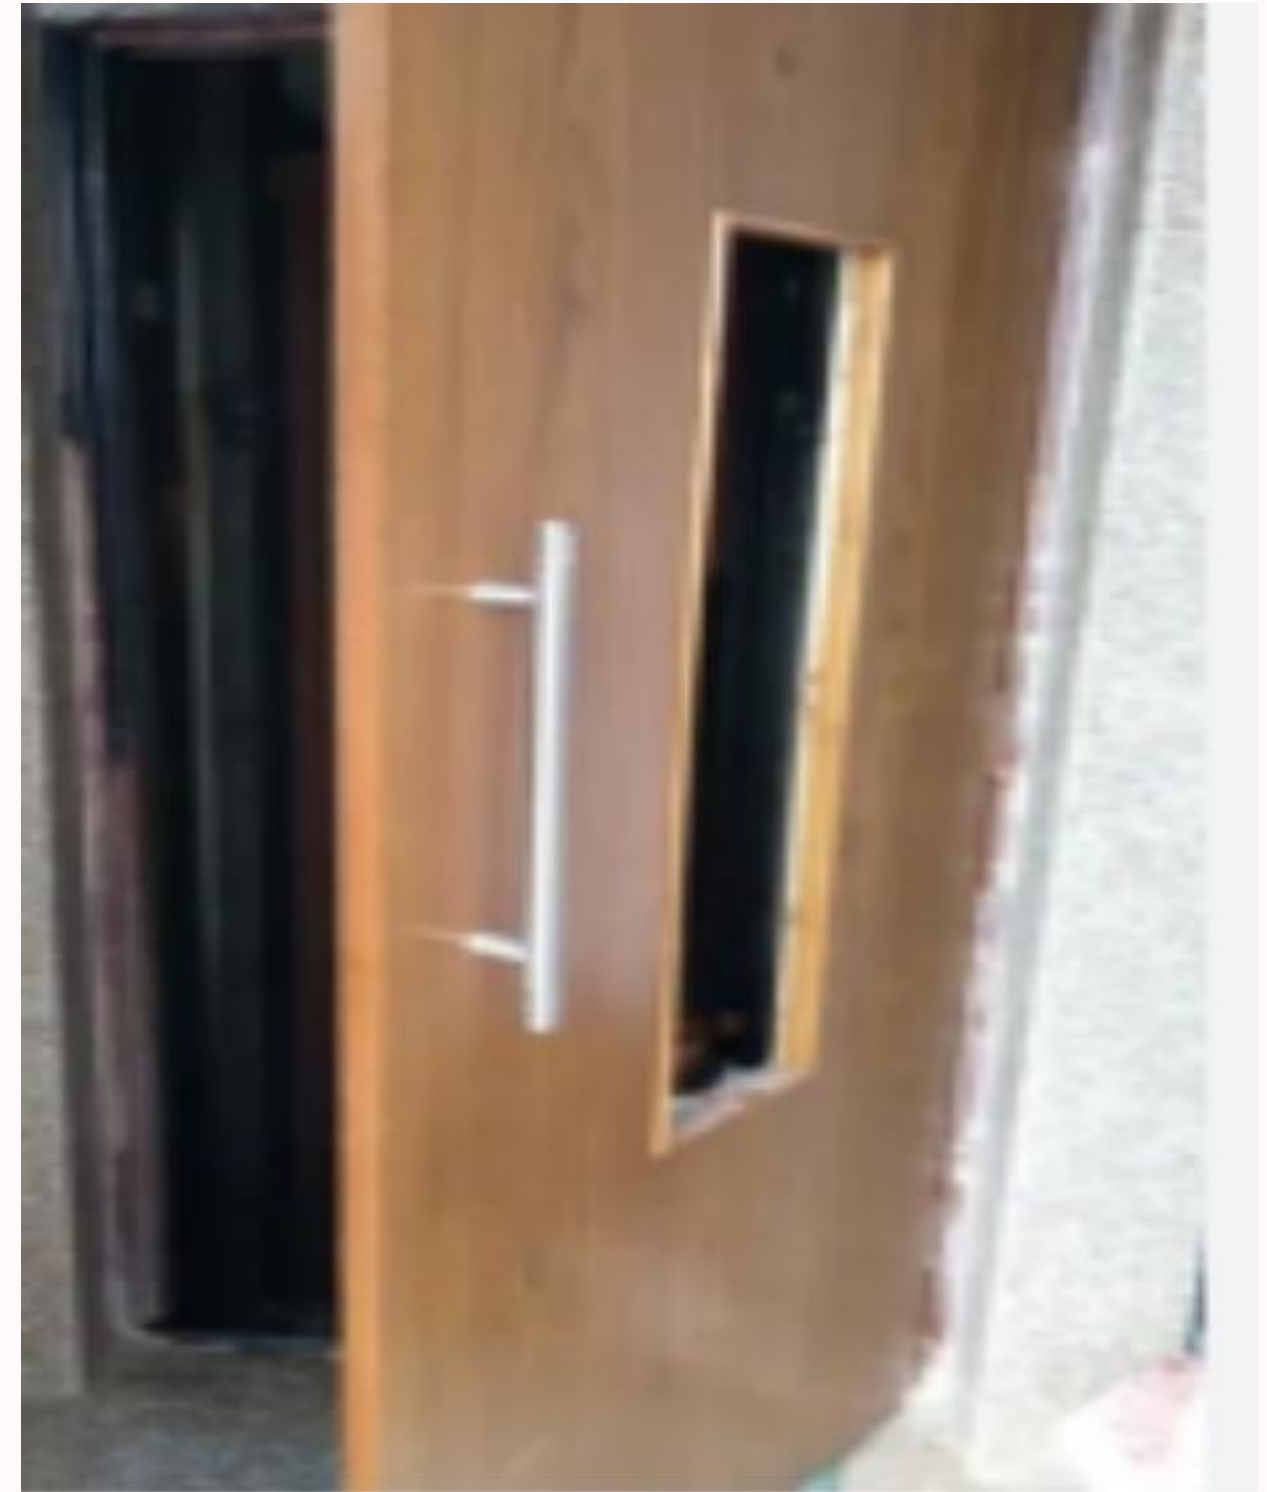
Incident Overview

A passenger visiting a relative in the building opened the ground floor elevator door from outside, assuming the elevator was present. Upon stepping forward, the passenger fell into the elevator pit. While attempting to escape, the descending elevator caused serious injuries to the fallen passenger.

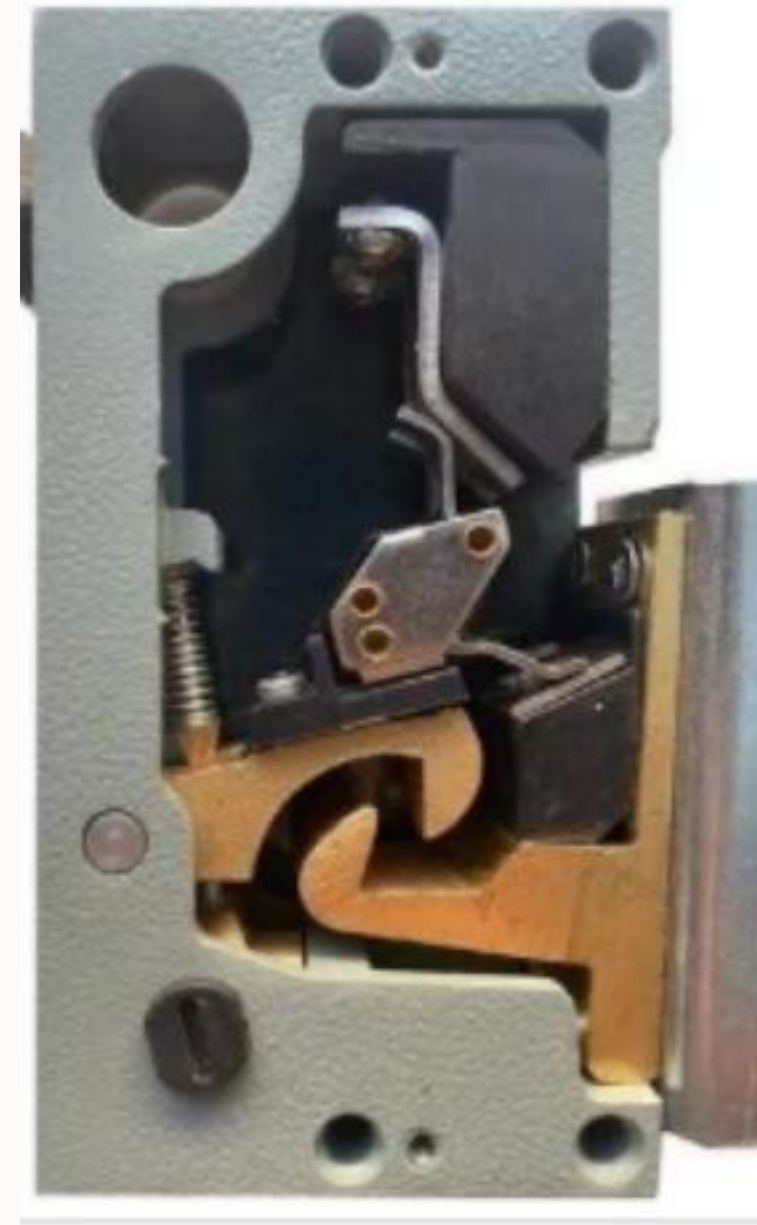
Compromised Door Safety

Ground floor doors were electrically shorted, allowing the elevator to operate with landing doors open

Mechanical Failure

Ground floor door lacked proper mechanical locking, enabling passenger access (open the doors)when elevator wasn't present

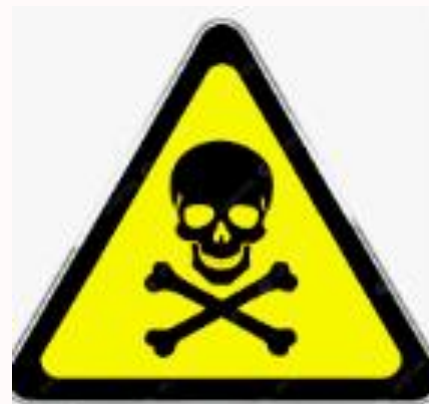
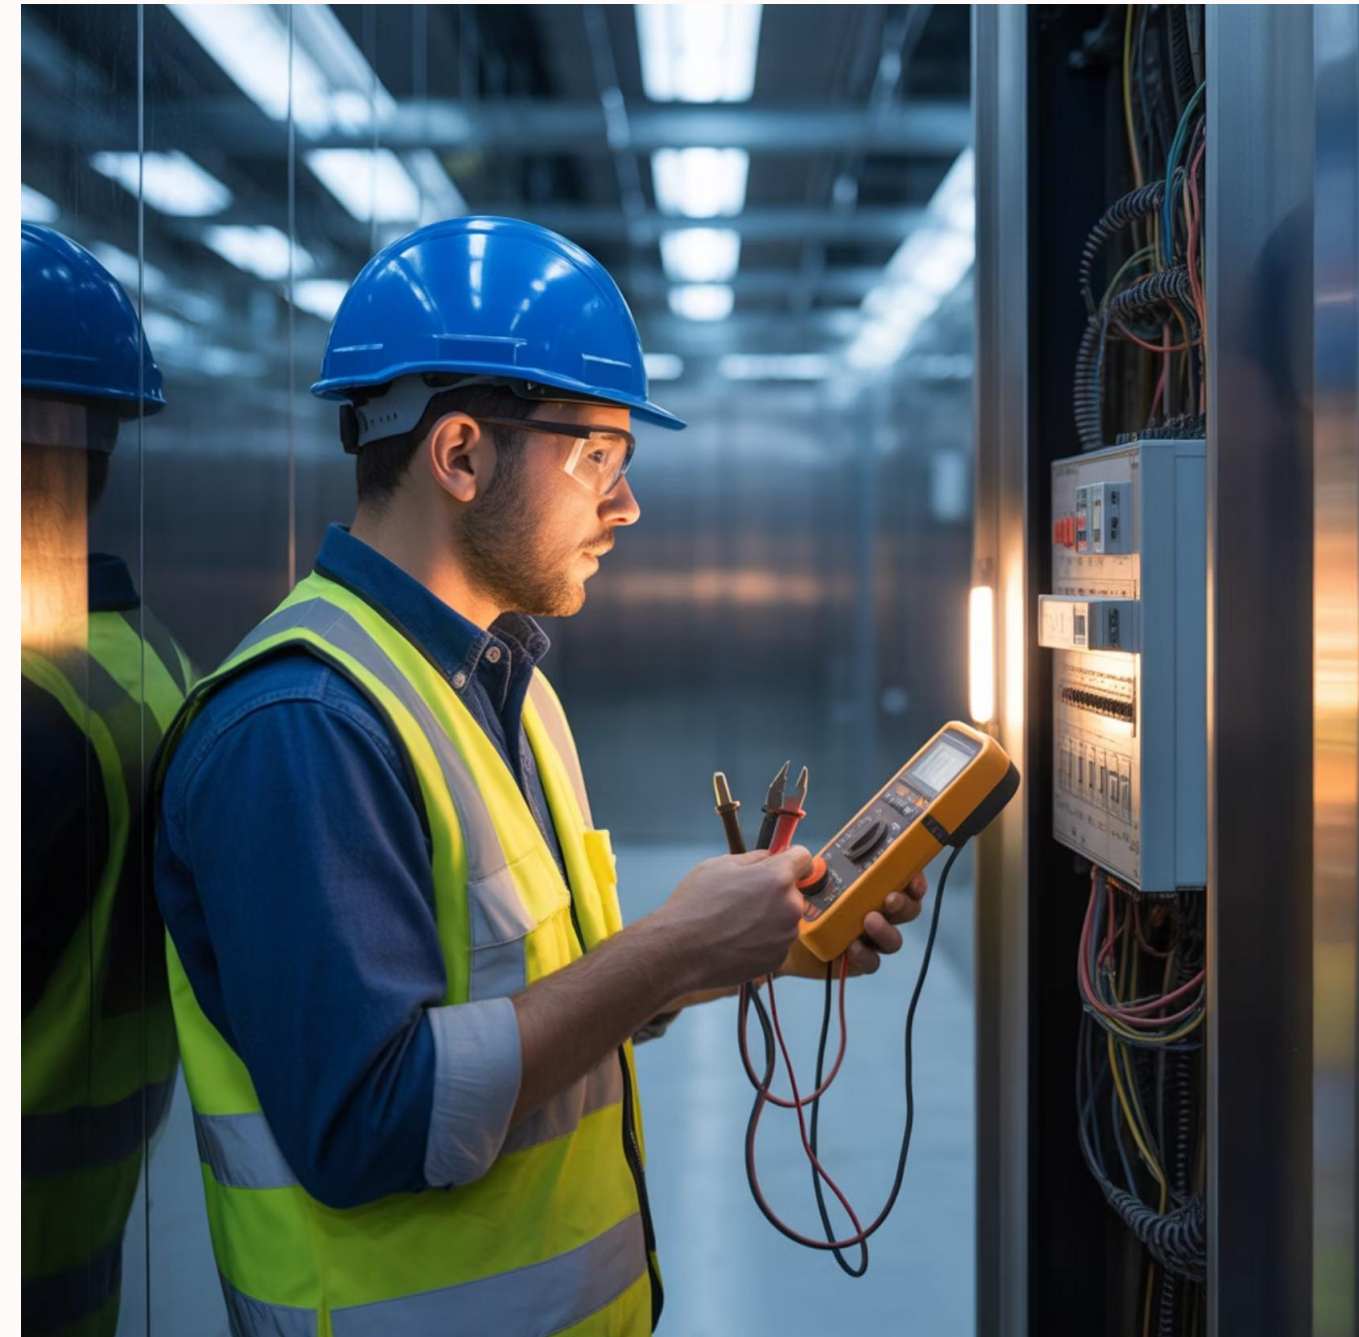
Root Cause Identified

Maintenance Shortcut

The mechanic had shorted the ground floor lock circuit as a temporary measure after discovering the lock shorting strip was damaged.

The technician intended this as a temporary solution until replacement parts could be retrieved from stores, but left the elevator in normal operation with this critical safety feature disabled.

Technical Repairs

Lock components were replaced and properly adjusted to restore safety functionality
